SSD 10459 - Central Sydney Industrial Estate

## ESTATE LANDSCAPE MANAGEMENT PLAN (EXCLUDING LOT 6 DOWNER)

Report Ref: **190130\_CC\_RPT\_LAN\_LMP02**

1<sup>ST</sup> FEBRUARY 2021

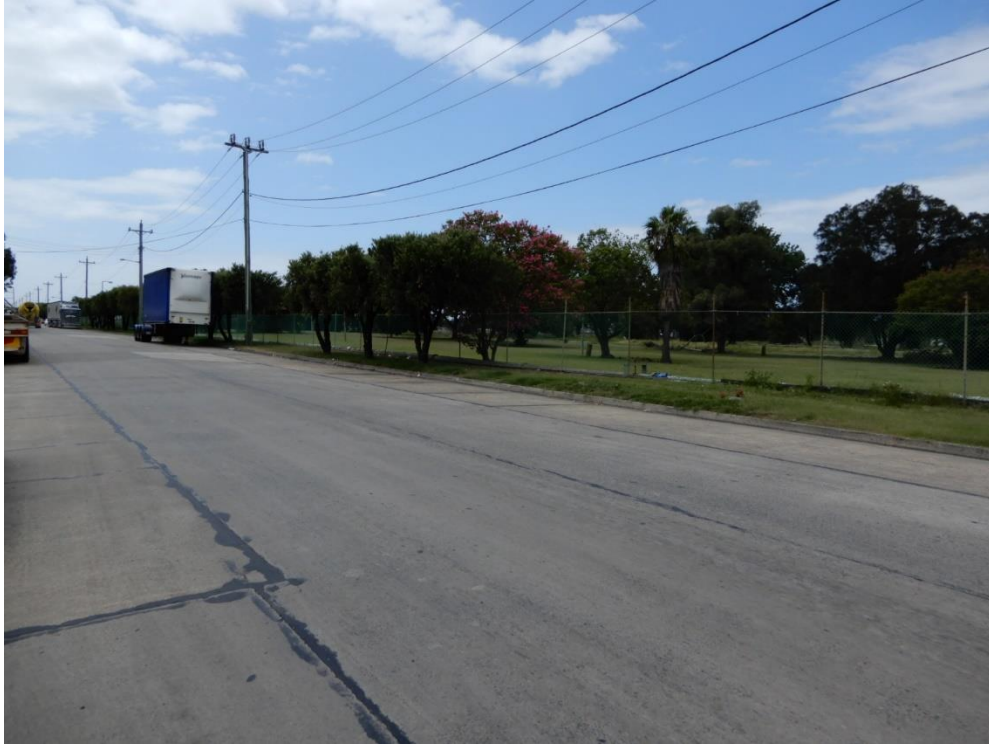
Photograph 1: Illustrating the location and context of the trees along Devon Street.

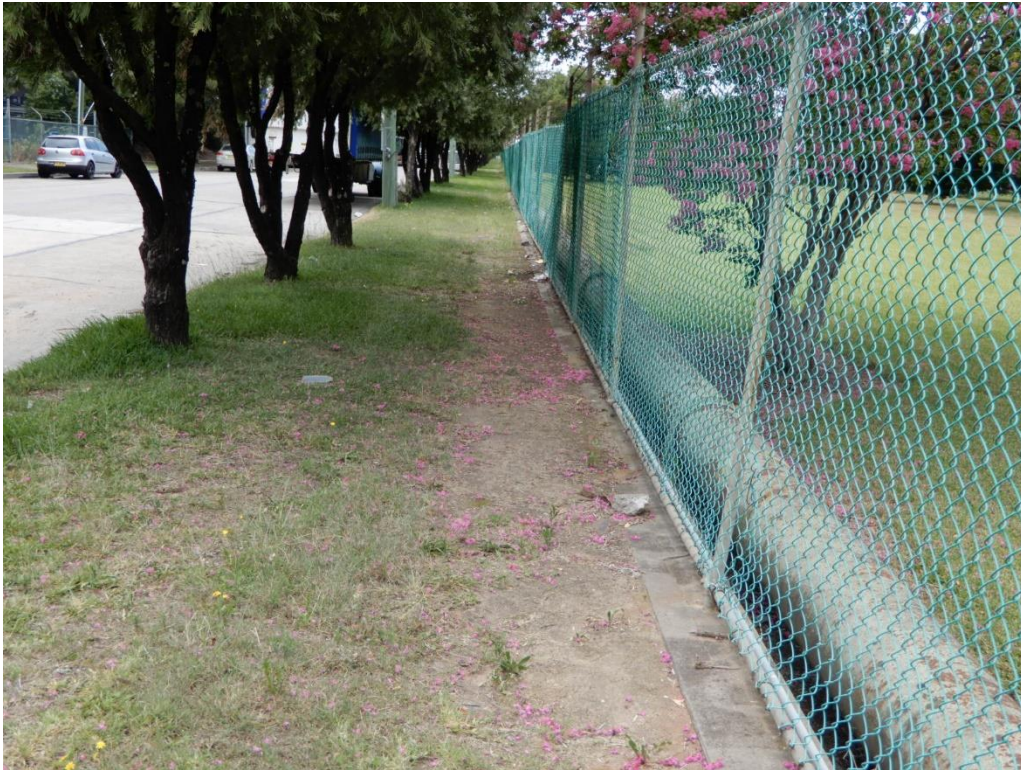
Photograph 2: Illustrating the location of the trees within the nature strip area.

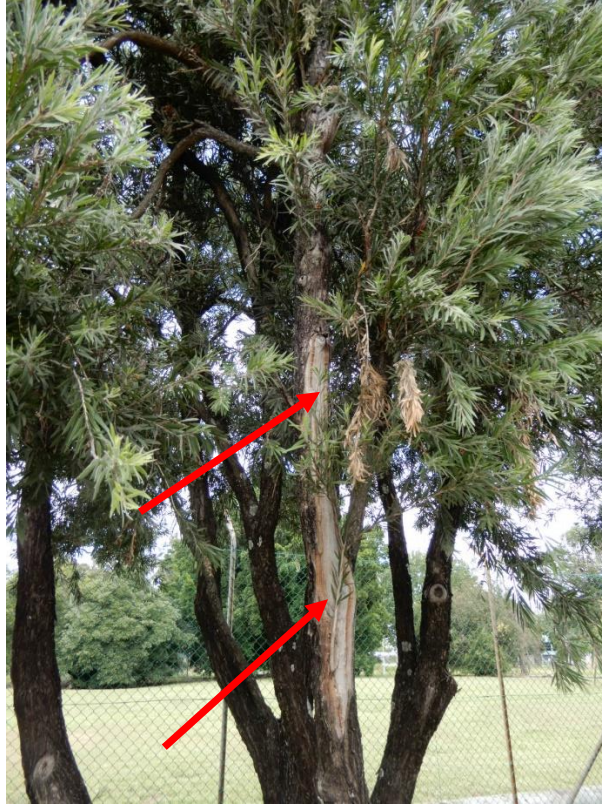
Photograph 3: Illustrating past mechanical damage from vehicle impacts.

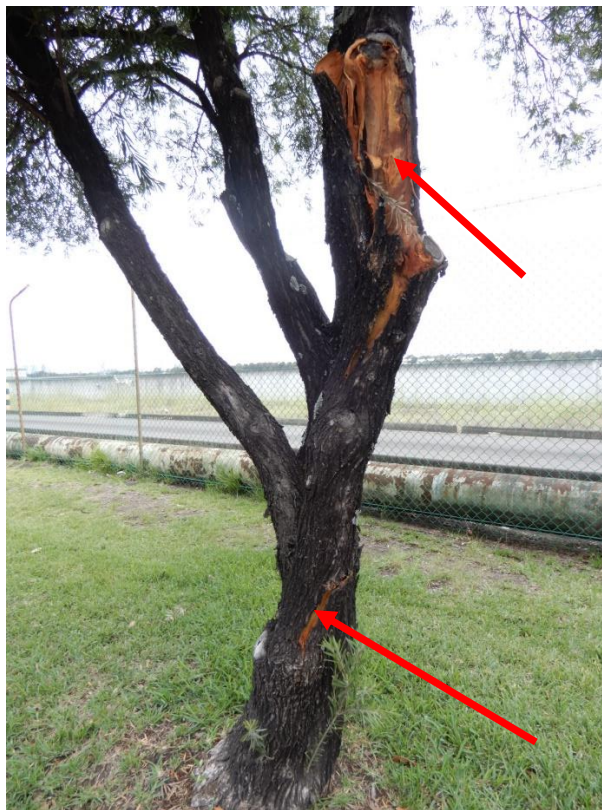
Photograph 4: Illustrating a recent branch tear from vehicle impact.

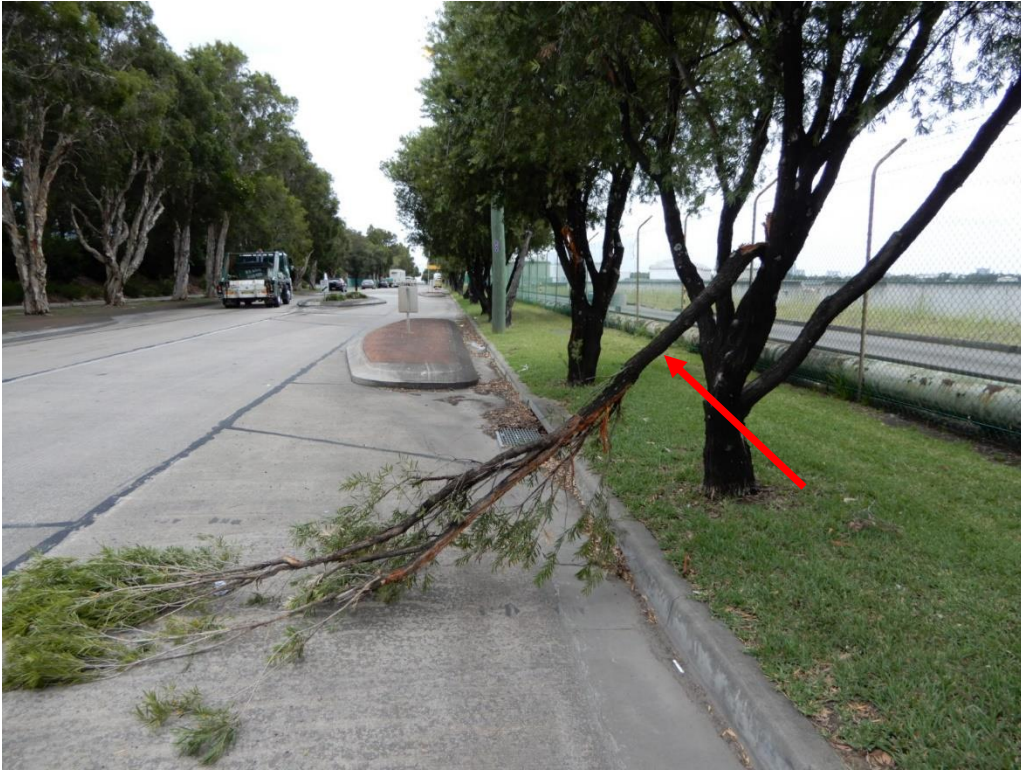
Photograph 5: Illustrating a recent branch tear from vehicle impact.

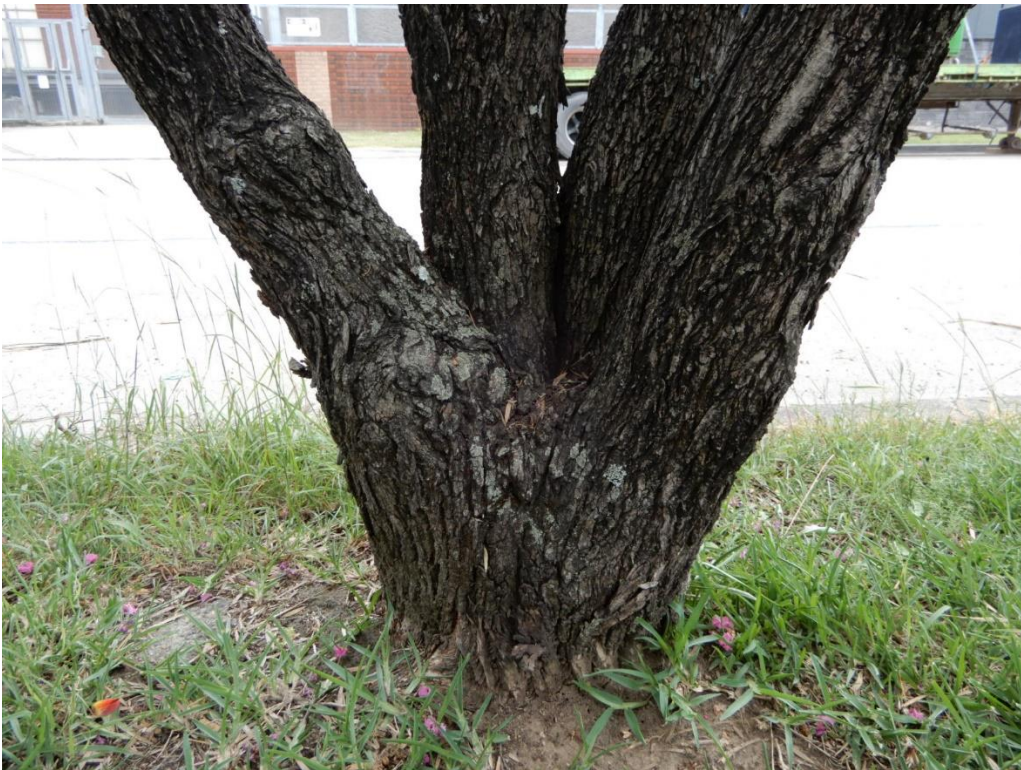
Photograph 6: Illustrating the multiple leaders from near ground level in many of the trees

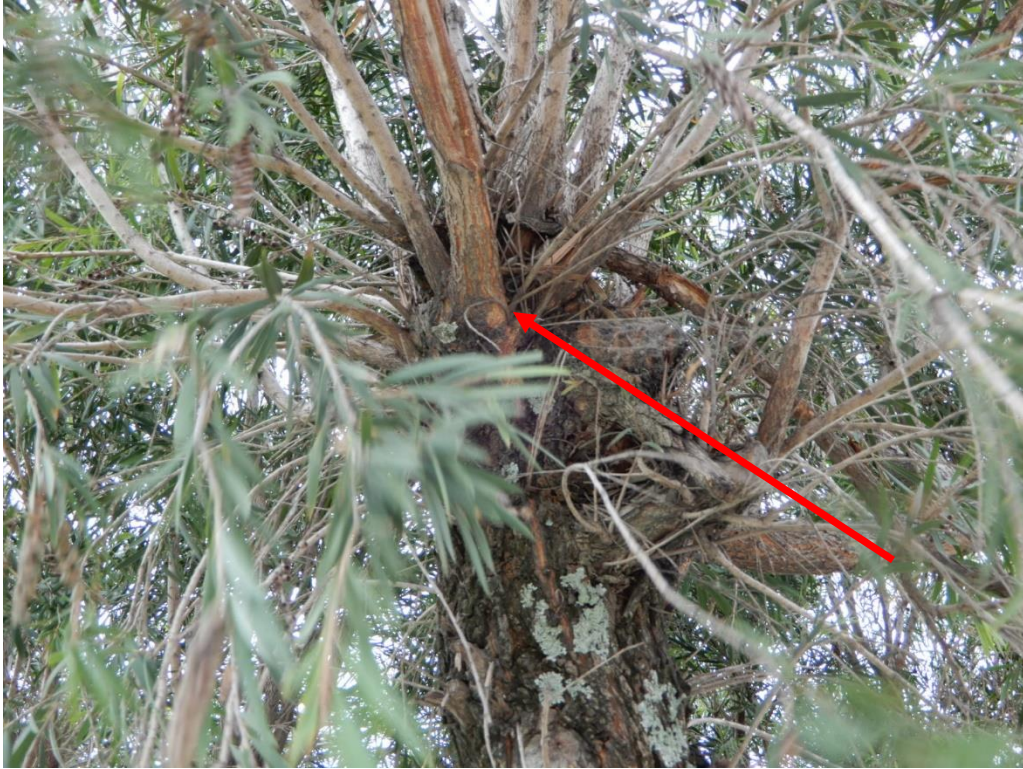
Photograph 7: Illustrating the multiple regrowth following past pruning for OH wires.

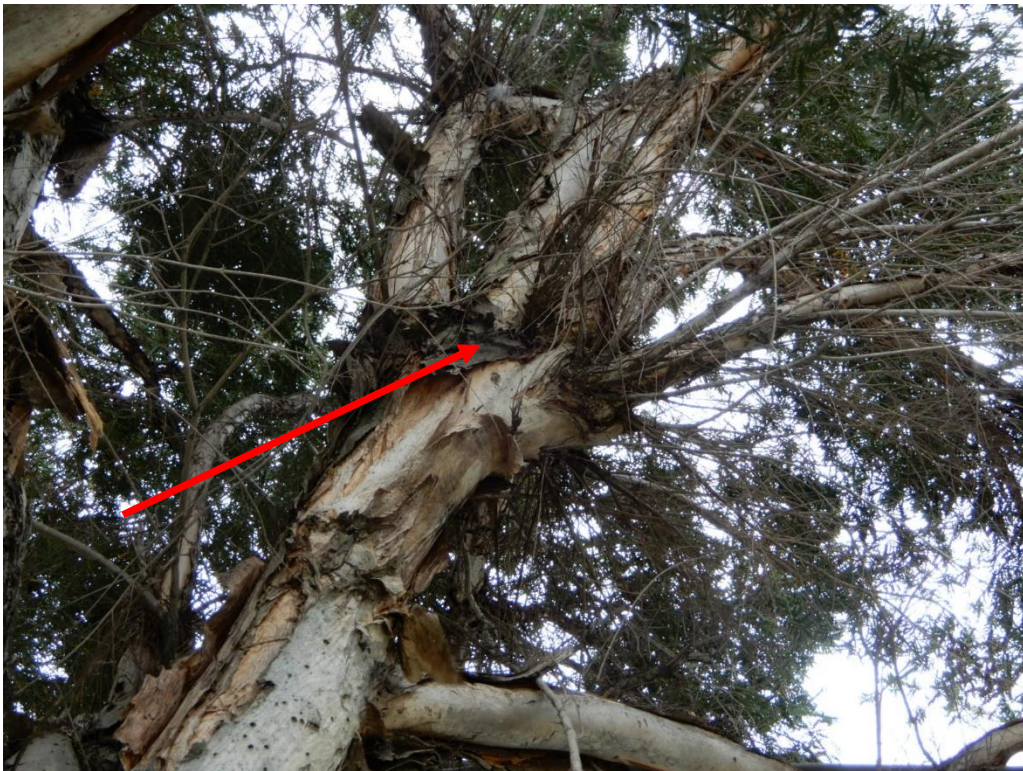
Photograph 8: Illustrating the multiple regrowth following past pruning for OH wires.
